WeatherVane

March, 2003

VOL. 17, ISSUE 1

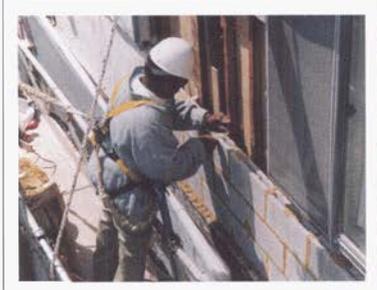
constructed in 1960 of masonry and concrete with brick headers on concrete slab as bearing support for the walls. The concrete frames had begun to *shrink*, while the brick expanded, causing pressure to build up in the walls.

“We located areas where the brick had moved or bulged out of the plane of the wall, and developed a plan for addressing the most vulnerable areas first,” said Mike Nagle of Brisk.

Wall movement was more than 3” in many areas, causing significant damage to interior plaster walls.

The Brisk crew removed displaced bricks, installed shelf angles and rebuilt damaged areas, using new brick that matched the original material. Addi-

The Brisk crew removed displaced bricks, installed shelf angles and rebuilt damaged areas, using new brick that matched the original.

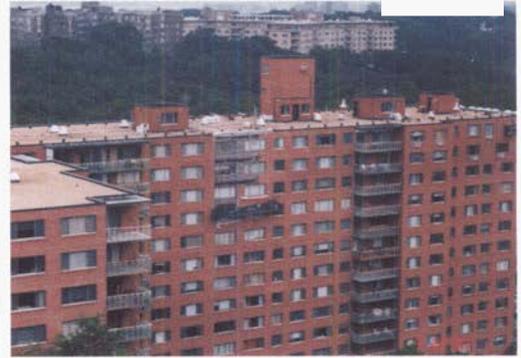
The masonry-and-concrete condominiums were constructed in 1960 with brick headers on concrete slab as bearing support for the walls.

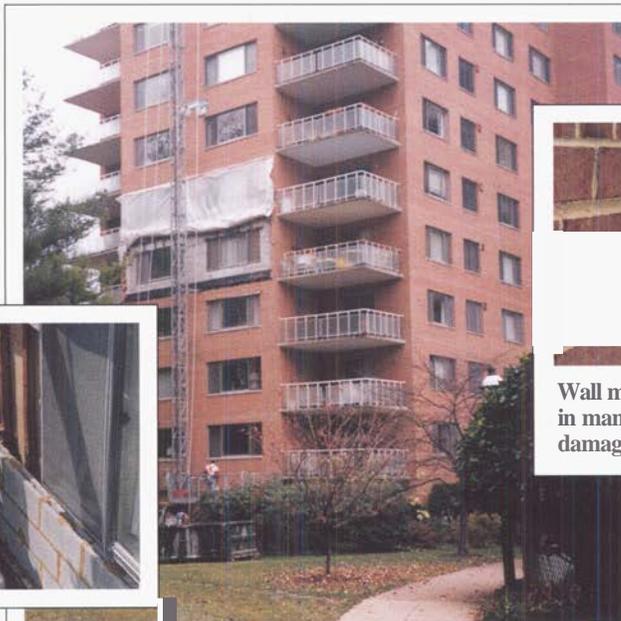
because the wall movement was over three inches in many areas and a lot of the block back-up wall had been pulled out beyond the edge of the supporting floor slab. This had caused significant damage to the interior plaster wall attached to the block back-up walls. The foreman for Brisk, Freddie Jenkins, and his guys did a fantastic job of replacing the affected block wall areas and re-securing the plaster lath without

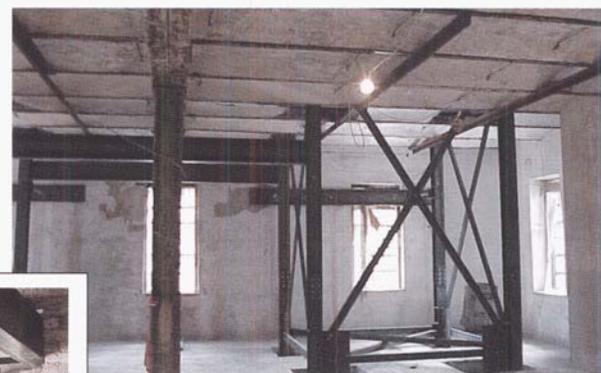
Above: Steel towers erected inside the structure stabilize the walls.

was called in to install steel towers to support the walls and prevent further movement. The Rockville, Md. office of Simpson Gumpertz & Heger, Inc., Consulting Engineers, served as the engineer on the project.

footings to support the steel towers. The footings each measured 12 ft. by 12 ft. by 5 ft. The crew erected the towers inside the building, going up through the second and third floors of the old jail. The masonry walls were then tied back to the towers to prevent further movement.

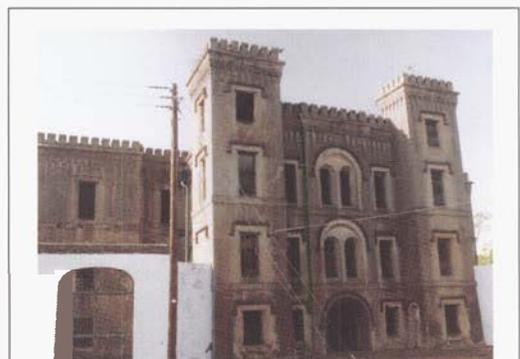
"As the tension rods began to rust, the brick arches relaxed, allowing the floor to flatten and push out against the masonry walls. The east and west walls were in real danger of collapse."

Built in 1802, Charleston Old City Jail was in use as a prison until 1939.

"We carefully monitored the walls for vertical movement throughout the project," explained Bill Heaner, Charlotte branch manager. "It was critical that our work not cause any more movement. Those walls were close to failing."

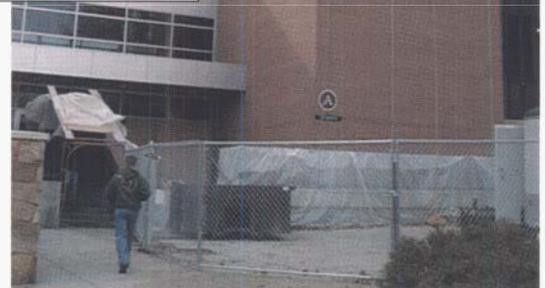
"With age and weathering, the masonry had begun to shift," explained Roger Hines, Assistant Superintendent for Maintenance Construction at the university. "The building was constructed without adequate provisions for expansion and contraction of the brick veneer. Consequently, the veneer failed at the corners."

The masonry removal also revealed inadequate wall ties to anchor the veneer to the superstructure, according to Hines.

Western removed and replaced the old brick from two corners of the Neckers Building.

Western removed the old brick at two corners of the building; re-laid new brick with new wall ties and cut in expansion joints. Because of the location, pedestrian traffic was a key concern.

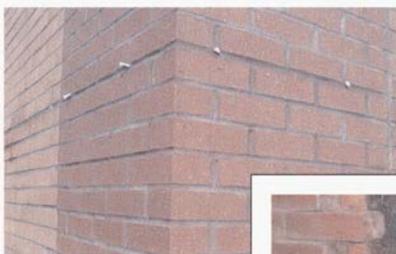
Western re-laid 15,000 bricks and cut new expansion joints on both buildings.

In the process of repairing Neckers Hall and the Engineering Complex, Western re-laid 15,000 bricks and installed more than 1,200 new masonry veneer anchors.

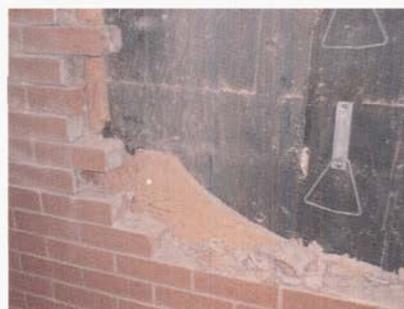
More than 1,200 new masonry veneer anchors were installed.

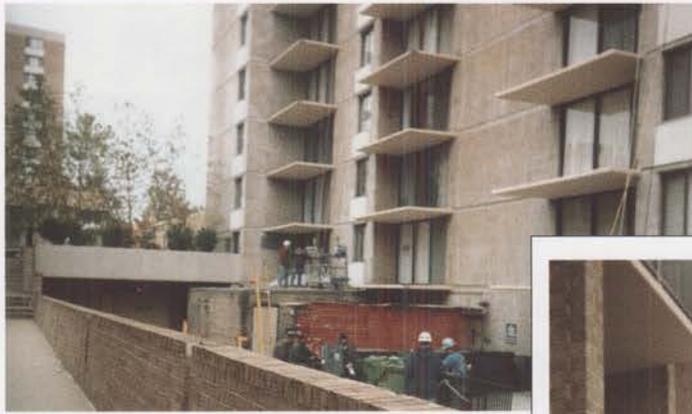
"The balcony railings were embedded in the concrete slab," explained Mike Ferro, branch manager for the H.S. Peterson Company in Beltsville, Md. "As the railings began to rust, the expansion of the metal caused the concrete to spall."

Railings were removed by hand and refitted with aluminum shoes and stainless steel hardware.

The Peterson crew worked on the balconies of all nine garden structures, as well as four floors of the high-rise towers. Sonneborn products were used to repair spalled areas. Miracote coating was applied to the topside slabs. Prior to reinstallation, the railings were fitted with new aluminum shoes with stainless steel hardware. Floyd Parks supervised a two-person crew for Peterson throughout the project.

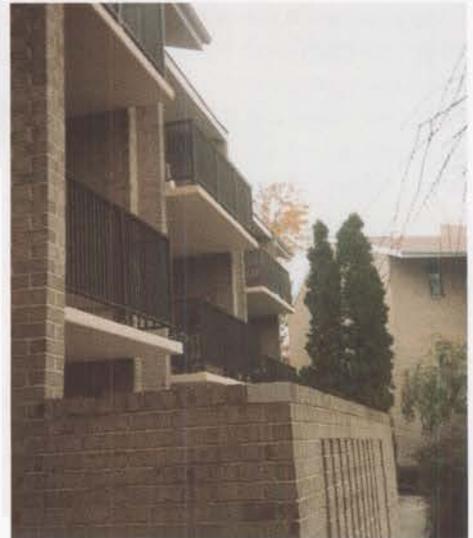
The Peterson crew worked on all nine garden structures, as well as four floors of the two 14-story towers.

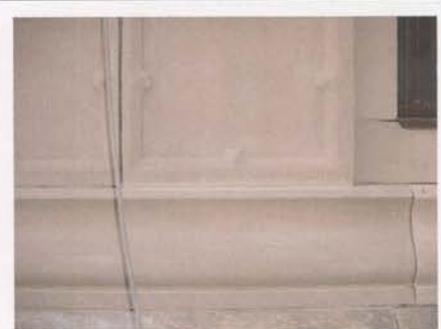
"We noticed loose stones in the limestone parapet at the very top of the building," said Dave Dupuy, branch manager of Western's New Orleans branch. "Closer inspection showed that the original anchors were severely oxidized. A survey of the whole building revealed the need for more extensive work. We ended up grinding out all the joints and re-pointing the entire building."

The original scope of work called for cleaning and sealing the exterior, plus re-caulking and re-glazing the windows.

In addition, the Western crew secured the parapet walls with steel reinforcement, patched spalled limestone and mechanically re-anchored stone wherever necessary. Stephen Parks of Western supervised a

Western's crew re-pointed the entire building and patched limestone where necessary.

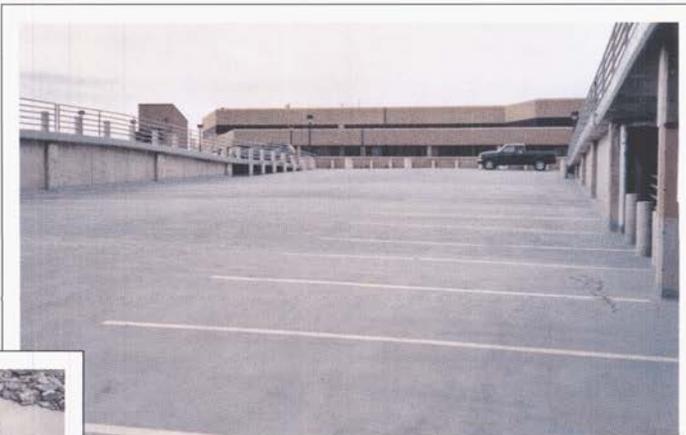
The Government Center Parking Terrace is a five-level, post-tensioned structure. Western kept a minimum of 75% of spaces available throughout repairs.

The major portion of the work involved recoating 200,000 sq. ft. of the parking deck with urethane traffic mem-

brane. The project also included caulking construction joints, repairing cracks and patching concrete. Conventional cementitious patching

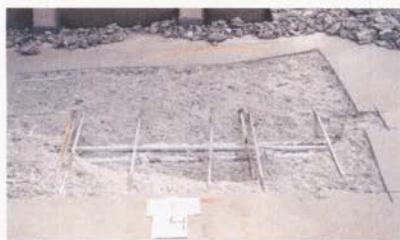
In addition to recoating the parking deck, the project also included concrete repair and patching.

material was used as well as urethane mortar for shallow-
