BEST OF

WEATHER VANE

Published by
WESTERN CONSTRUCTION GROUPAmerica's Master Craftsmen in
Building Restoration and Preservation

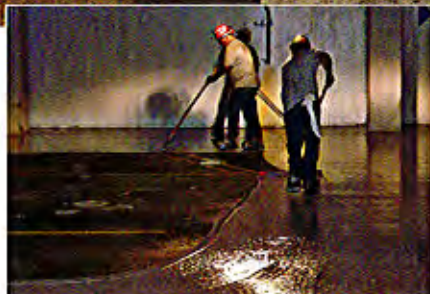
Harry S. Peterson Company did it by the numbers: installing 180,000 square-feet of urethane deck coating, maintaining 24/7 facility operation, achieving 100% client satisfaction.

In this case, that expertise was evidenced in an eight-phase plan, a seven-person crew and a schedule that called for coating installation on weekends only. The HSP team met all deadlines, including working over the Memorial Day weekend, to install the 180,000 square-feet of Lyntal urethane deck coating.

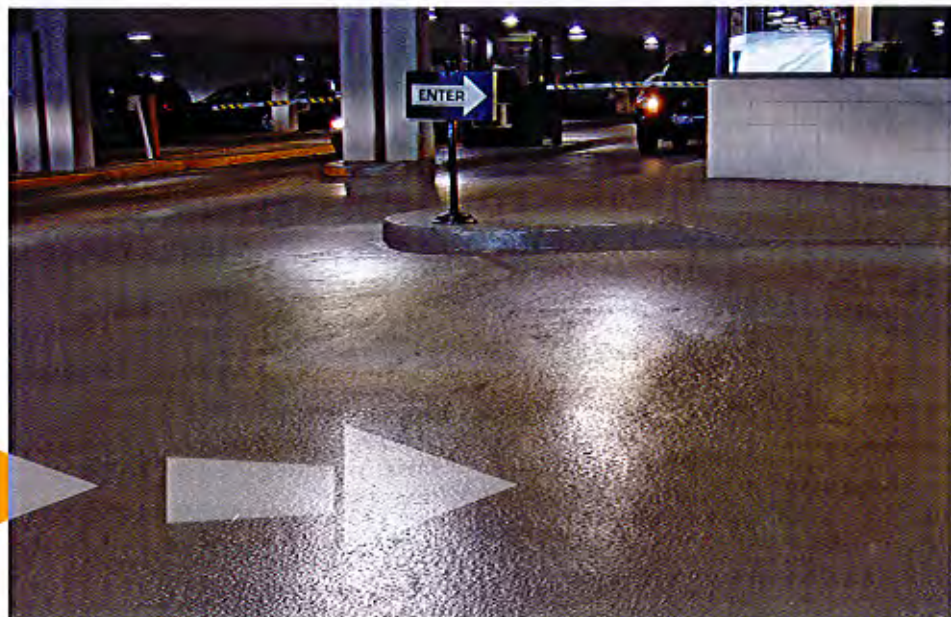
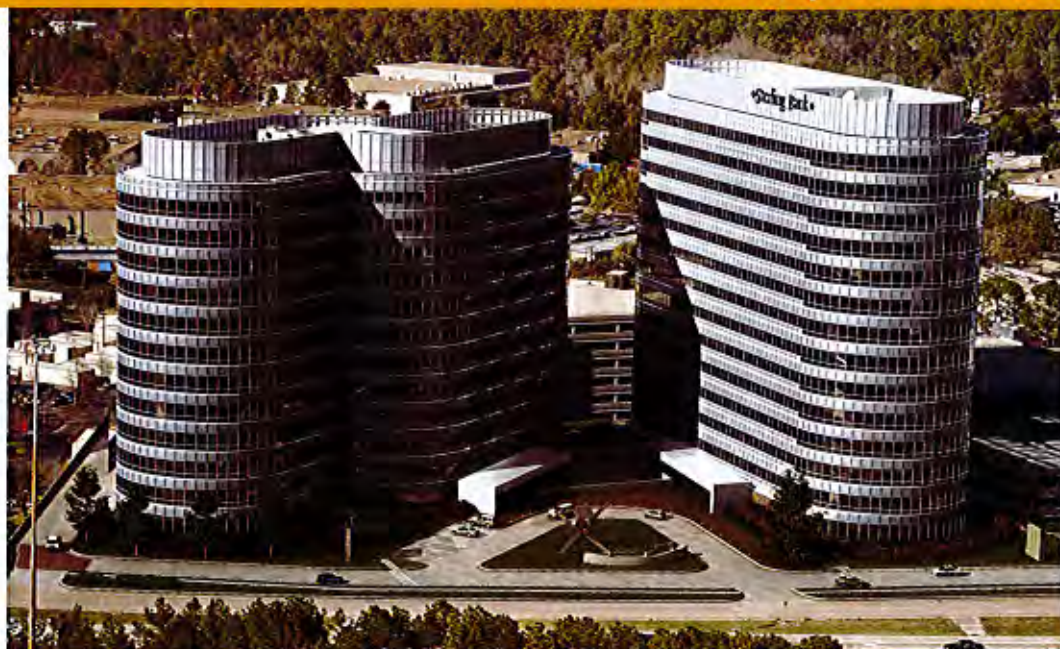
Brookhollow II & III *Houston, Texas*

Close collaboration among Thomas Properties Group, Engineering Diagnostics and Western yielded positive structural and aesthetic returns for Brookhollow II and III. A striking silver and glass theme transformed the 1970s complex into a 21st century beauty.

Properties Group in conjunction with Engineering Diagnostics, Inc. in 2007 to address several exterior façade issues at Brookhollow II and III. Several of the metal panels in the buildings' signature curtain walls were broken and sealants had deteriorated. Moreover, notes Houston branch manager Charlie West, a complete exterior restoration was vital for Brookhollow II & III to complement the new exterior of Brookhollow I.

Western crews overclad broken and cracked metal spandrel panels and installed custom-color preformed seals over the curtain wall butt joints. Panels and windows in the wall system were wet-sealed, snap covers replaced and aluminum covers installed at the accent band joints. Then came the paint—the choice of which had been decided in a Houston downpour with Thomas Properties' team members sheltered by Western umbrellas.

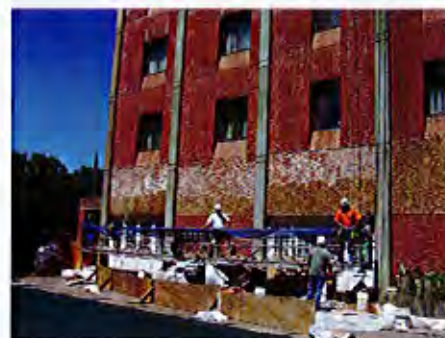
Heideman's examination revealed that age and exposure to the elements had caused deterioration of the structure's steel clips and shelf angles. The firm also determined anchors had corroded due to a chemical reaction with the Sarabond design. Without rapid repair, the integrity of the building was at risk. Western was tapped for the more extensive restoration.

Engineers traced structural problems at the Eight Sixteen Club Condos to two sources: general deterioration caused by age and elements and chemical reactions between anchors and the Sarabond design. Western removed failed components; installed new angles, clips or galvanized shelf angles; then replaced and sealed exterior brick.

Repairing the Eight Sixteen Club required the removal of existing brick to expose failing angles and clips and installing new angles, clips or galvanized shelf angles in their place. New brick was then installed and sealant applied at the vertical joints.

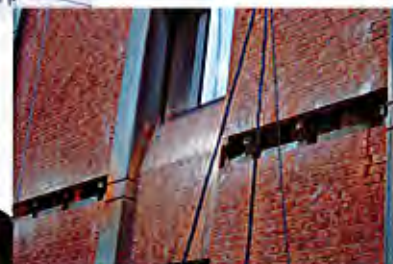
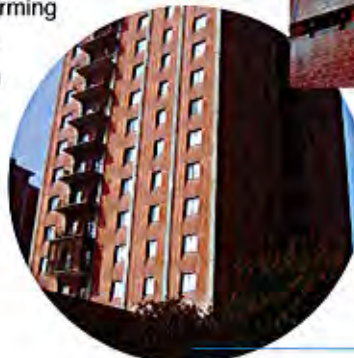
Safety and communication issues were of utmost importance as the highrise condominiums were fully occupied throughout the course of repair. Western won high praise from owners and managers on both counts.
