WEATHER VANE

Published by
WESTERN CONSTRUCTION GROUP

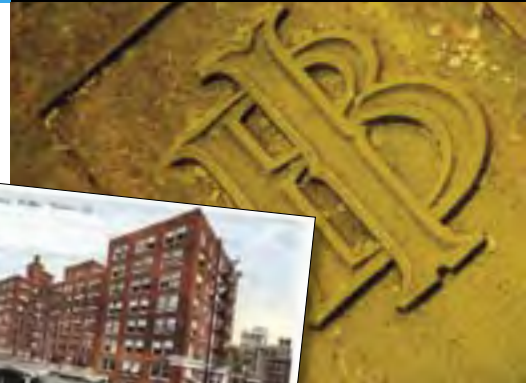
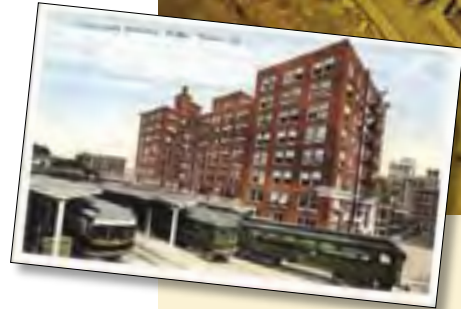
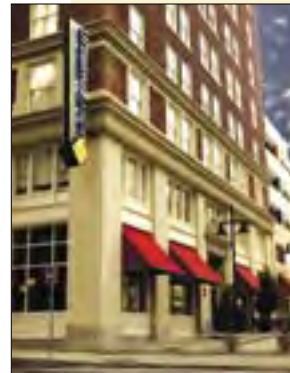
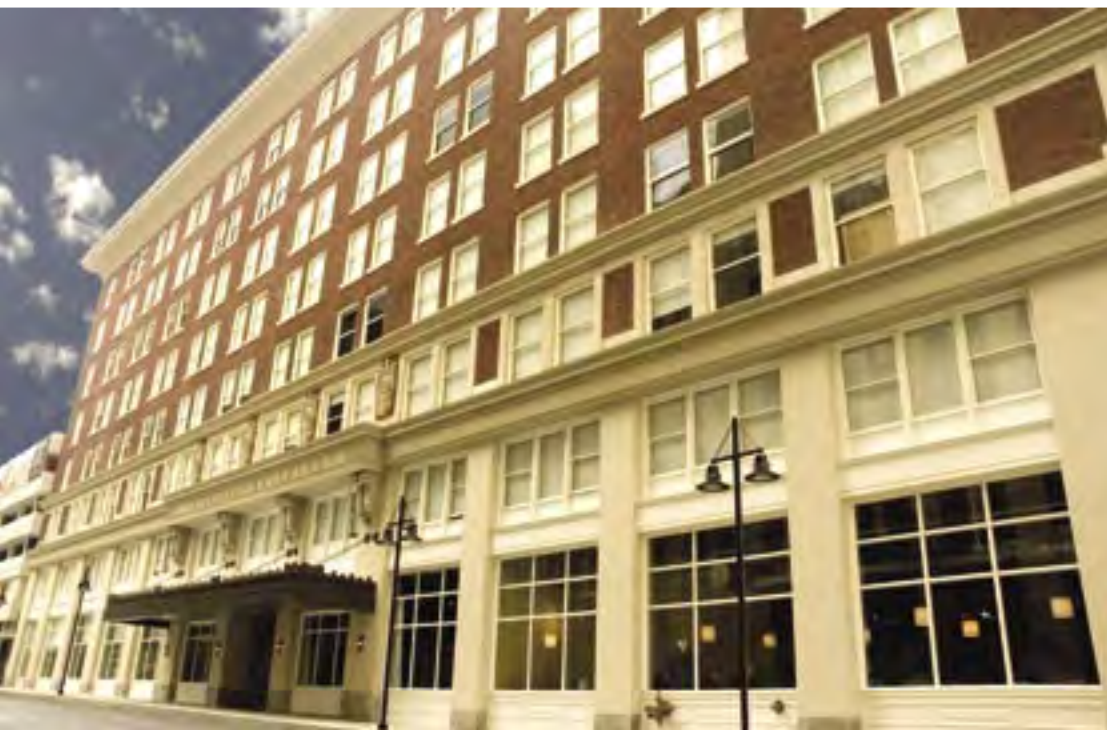
The Interurban Building served as a hub for light rail lines.

Top left: The building in its heyday.

Middle right & above: The building fell into disrepair and was stripped of exterior ornamentation in the 1970s.

Middle left & far left: Restored to its original appearance, it's now a mixed-use (residential/retail) structure.

ing. And Western's Dallas branch was tapped to restore the building's exterior, which had been stripped of ornamentation in the 1970s, to its original appearance. The scope of work included exterior cleaning, tuckpointing, brick and concrete masonry unit replacement, stone setting, and granite and paver installation.

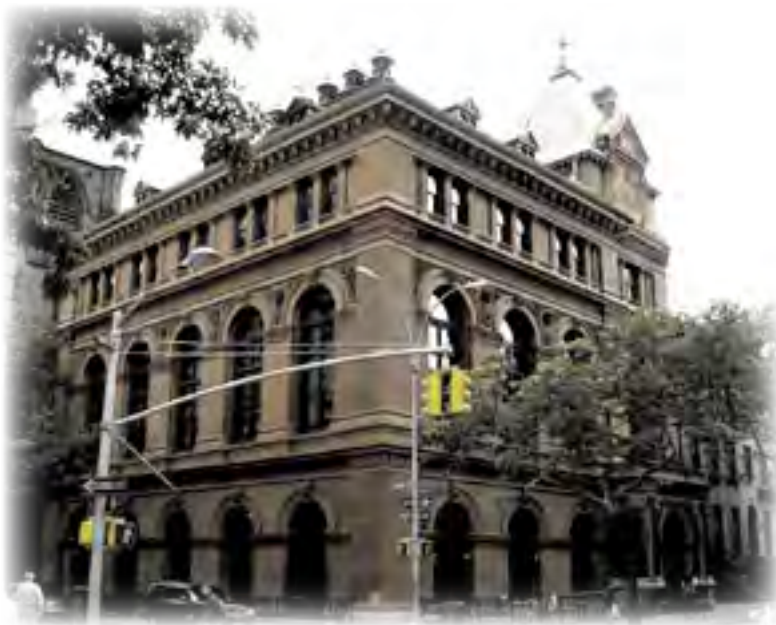
Both the brick and terra cotta were laid with “battered” joints, typically 1/16” to 1/8” wide. Raking the narrow joints for repointing required both precision and skill to avoid damaging adjacent masonry. Matching materials and workmanship to the late 19th century original also was crucial. Gray mortar was carefully formulated for the brick masonry, while designed red mortar was used to repoint terra cotta masonry.

The façade cleaning also required extreme care, with close attention paid to dwell times. The terra cotta was masked and protected from the Prosoco project formulated Restoration Cleaner used to clean the brick masonry. After the brick masonry was cleaned, an alkaline poultice was used to clean the unglazed terra cotta.

Brisk Waterproofing Company was selected to restore the building’s masonry façade to its original warm red appearance while preserving the unique and orange terra cotta, as well as the irreplaceable pressed brick units.

Working closely with the owner, architect and conservation consultant, the Brisk Waterproofing Company successfully restored the masonry façade while preserving its historic and unique materials.

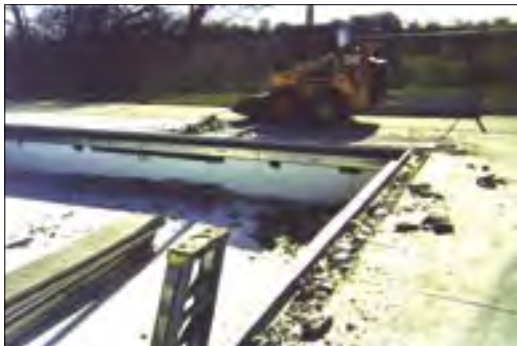
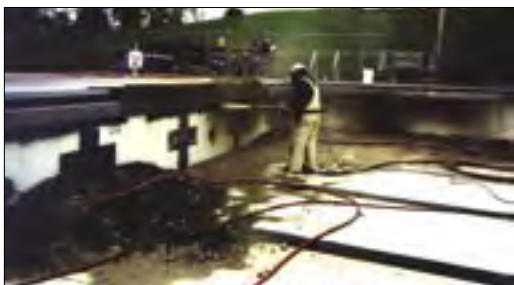
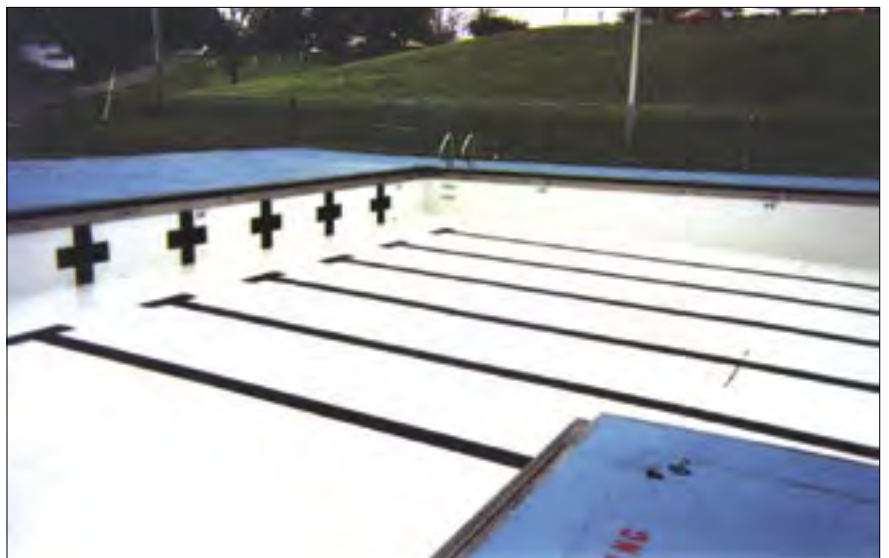
Western’s evaluation confirmed that decades of use and Iowa temperature extremes had taken their toll on the facility. Pool managers had reported dropping water levels in prior summers, a strong indication that floor cracks were significant. Scaling and peeling were prominent, with spalling evident around the perimeters of the pool’s built-in drain system. Given the stringent schedule, the five-man restoration crew had a challenge on their hands.

Restoring the community oasis in Colfax, Iowa, first meant resolving leaks caused by deteriorated concrete. With trouble spots corrected, Western’s five-man crew returned it to one cool pool with white decks and emerald blue accents true to the original.

The scope of work developed called for floors to be shotblasted and walls sandblasted to remove old, non-adhering coating. The concrete was then sounded, with areas of delamination marked. Once deteriorated materials were removed, vertical areas were repaired with air-placed concrete (gunite) and horizontal areas with 4,000-psi ready-mix concrete.

A two-coat epoxy coating system was applied to the fully cured concrete, with a light-aggregate broadcast employed to achieve an anti-slip surface. Per the customer’s request, pool floors were returned to their original white with decks receiving an emerald blue coating. With the application of floor striping and upper-deck safety warnings, the project was complete, and the start-of-summer deadline more than met.

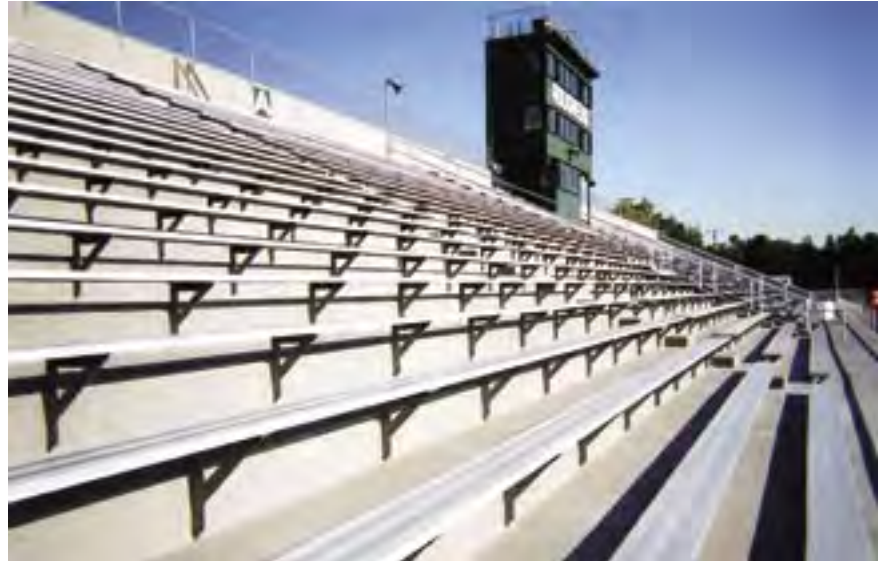
"The stadium was built in 1939 using concrete, a lot of river rock and a lot of rebar," Johnson begins. "To someone of my background, it didn't appear to be in jeopardy. But the architects said we had only three years' of usage left. Moisture inside had caused the rebar to deteriorate."

Color-matching the new top coat applied to vertical surfaces and the elastomeric coating used for vertical walls resulted in a crisp, coordinated look and prime protection for Muskogee's landmark stadium.

Western's role in the stadium-saving action included correction of concrete problems and application of deck coating to prevent future infiltration. "That last coating we'd applied was still in great shape when we were asked back this time," states Western branch manager Eric Birch. "So it was agreed that we'd apply a new urethane top coat."

This engagement, Western crews power washed the old coating, repaired damaged areas, and recaulked expansion joints. They then applied over 500 gallons of new top coat with sand back-rolled into it. Next followed an application of a color-matched elastomeric coating to all vertical walls.

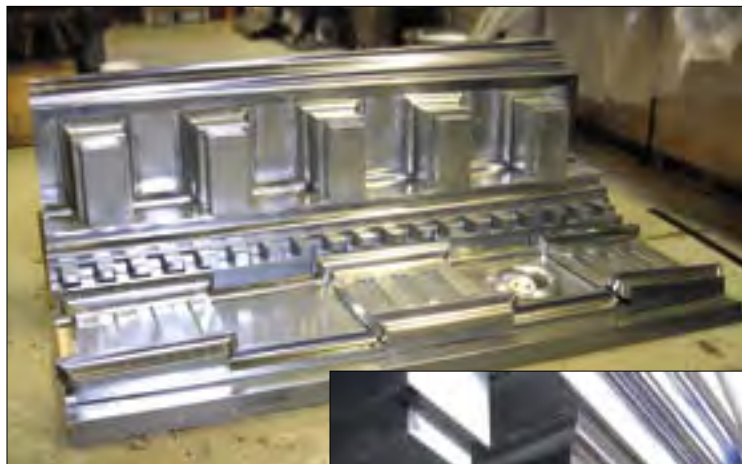
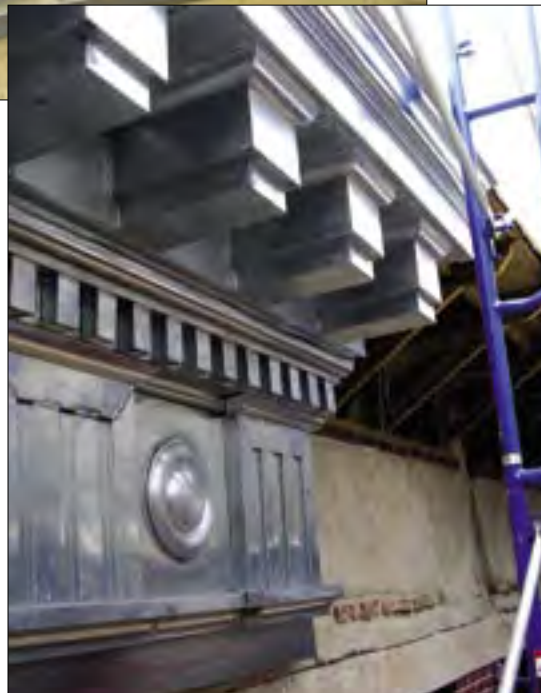
The new cornice was constructed of galvanized metal in eight-foot lengths, the industry standard for production and installation efficiency. Each piece was 48 inches high and constructed from five horizontal sections with different configurations. Some 80 panels contained spinnings.

Seventy years of wind and weather had compromised the intricate beauty of 40 Tiemann’s distinctive metal cornices. Craftsmen from Michigan Ornamental fabricated 144 lineal feet of design-enhanced replacements to restore the building’s original elegance.

To expedite restoration, Michigan produced the sections in three groups of six, allowing placement to begin while fabrication concluded. The crew also crafted and attached 84 brackets to a section of the upper cornice, along with 350 dentils, to speed installation.

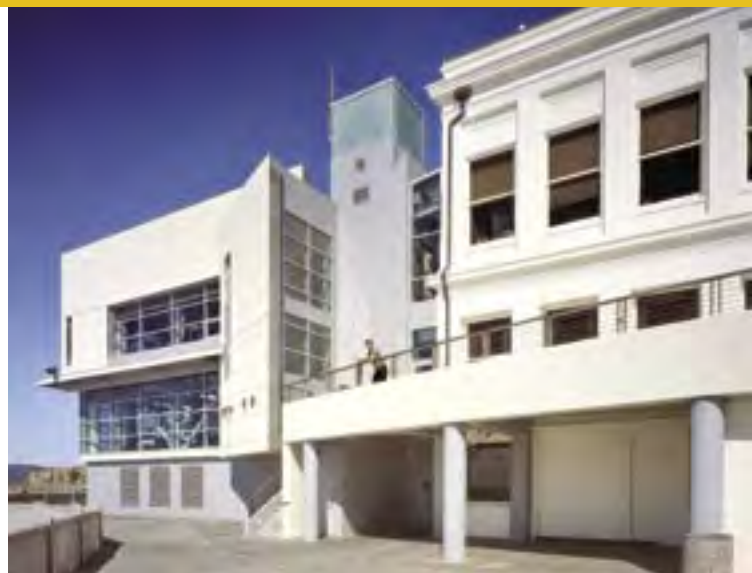
In late 2002, Western Waterproofing's San Francisco branch was asked to partner with Nibbi Brothers Construction and C. David Robinson Architects to restore portions of the Cliff House and expand the entertainment areas. Extensive research revealed that the building was constructed of concrete with details of putty parging.

A structural engineer was consulted when subsequent problems surfaced. Western performed the structural repairs indicated and added galvanic anodes to further reduce the effects of corrosion of the steel structural elements. Western was also asked to handle the temporary relocation and replacement of an historic Camera Obscura located on the edge of the cliff.

Plans called for rebuilding structural concrete base shapes and then applying putty to create column capitals and bases, cornices and other architectural elements. All of the products used would be stringently
