# WEATHER VANE

Published by  
**WESTERN CONSTRUCTION GROUP**

## Connecting the Past With the Future of Downtown Dallas

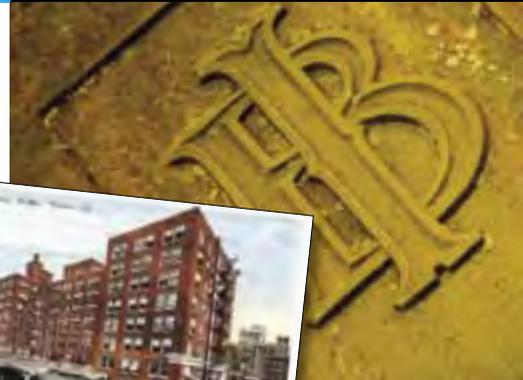
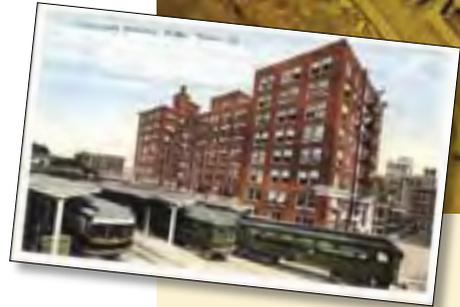
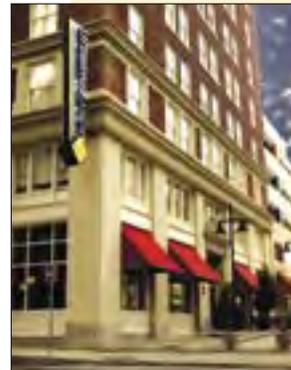
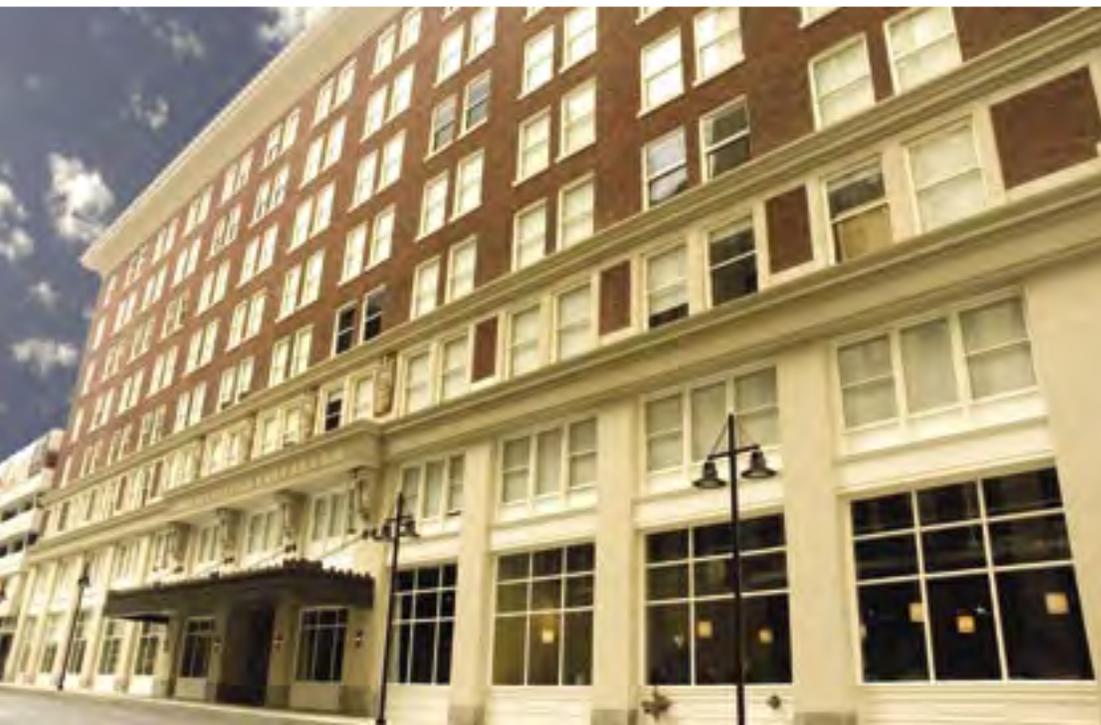
*The Interurban Building served as a hub for light rail lines.*

*Top left: The building in its heyday.*

*Middle right & above: The building fell into disrepair and was stripped of exterior ornamentation in the 1970s.*

*Middle left & far left: Restored to its original appearance, it's now a mixed-use (residential/retail) structure.*

ing. And Western's Dallas branch was tapped to restore the building's exterior, which had been stripped of ornamentation in the 1970s, to its original appearance. The scope of work included exterior cleaning, tuckpointing, brick and concrete masonry unit replacement, stone setting, and granite and paver installation.

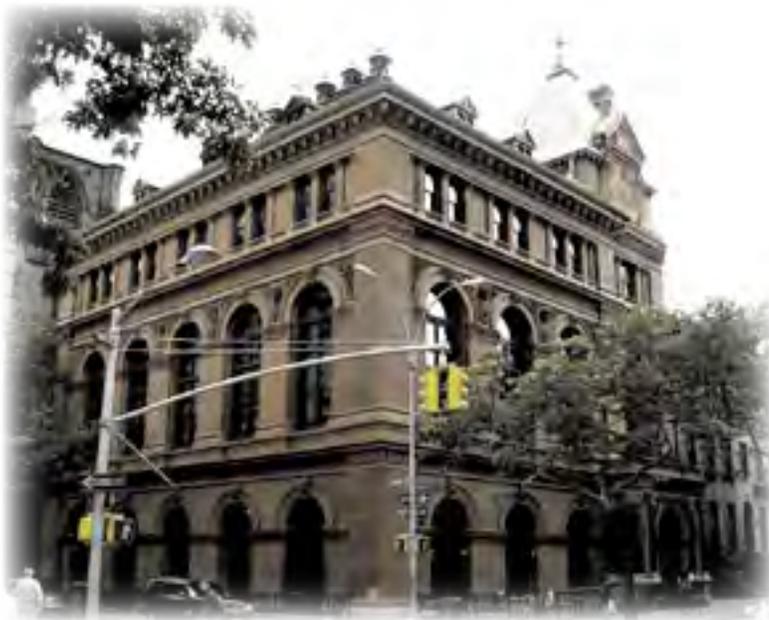
Both the brick and terra cotta were laid with “battered” joints, typically 1/16” to 1/8” wide. Raking the narrow joints for repointing required both precision and skill to avoid damaging adjacent masonry. Matching materials and workmanship to the late 19th century original also was crucial. Gray mortar was carefully formulated for the brick masonry, while designed red mortar was used to repoint terra cotta masonry.

The façade cleaning also required extreme care, with close attention paid to dwell times. The terra cotta was masked and protected from the Prosoco project formulated Restoration Cleaner used to clean the brick masonry. After the brick masonry was cleaned, an alkaline poultice was used to clean the unglazed terra cotta.

Brisk Waterproofing Company was selected to restore the building’s masonry façade to its original warm red appearance while preserving the unique and orange terra cotta, as well as the irreplaceable pressed brick units.

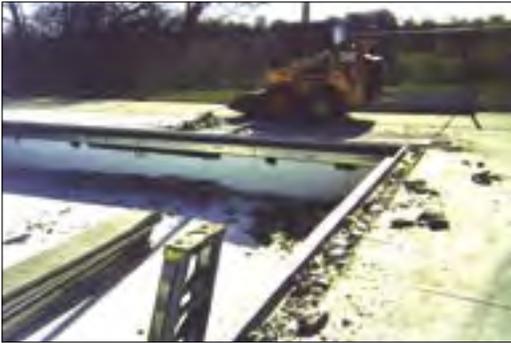
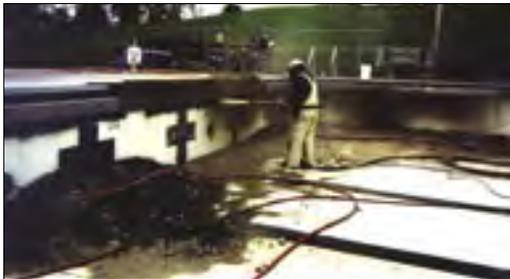
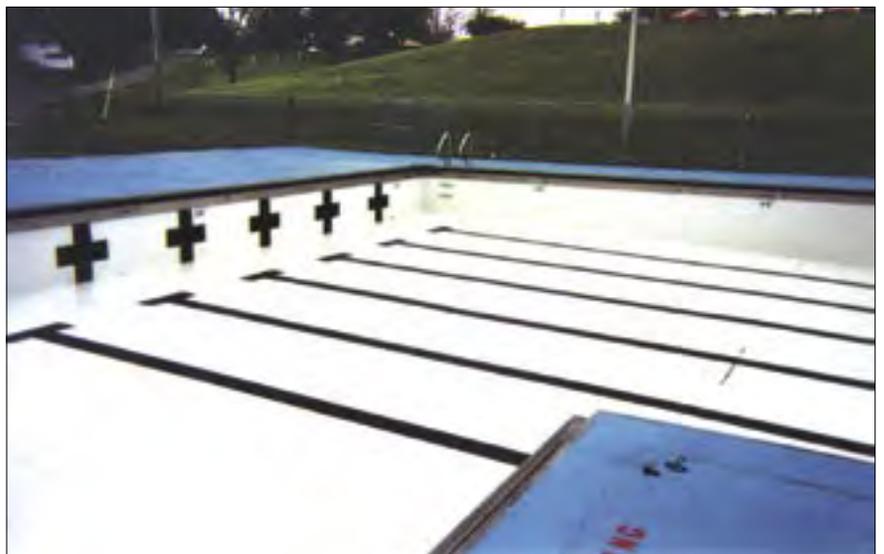
Western’s evaluation confirmed that decades of use and Iowa temperature extremes had taken their toll on the facility. Pool managers had reported dropping water levels in prior summers, a strong indication that floor cracks were significant. Scaling and peeling were prominent, with spalling evident around the perimeters of the pool’s built-in drain system. Given the stringent schedule, the five-man restoration crew had a challenge on their hands.

*Restoring the community oasis in Colfax, Iowa, first meant resolving leaks caused by deteriorated concrete. With trouble spots corrected, Western’s five-man crew returned it to one cool pool with white decks and emerald blue accents true to the original.*

The scope of work developed called for floors to be shotblasted and walls sandblasted to remove old, non-adhering coating. The concrete was then sounded, with areas of delamination marked. Once deteriorated materials were removed, vertical areas were repaired with air-placed concrete (gunite) and horizontal areas with 4,000-psi ready-mix concrete.

A two-coat epoxy coating system was applied to the fully cured concrete, with a light-aggregate broadcast employed to achieve an anti-slip surface. Per the customer’s request, pool floors were returned to their original white with decks receiving an emerald blue coating. With the application of floor striping and upper-deck safety warnings, the project was complete, and the start-of-summer deadline more than met.

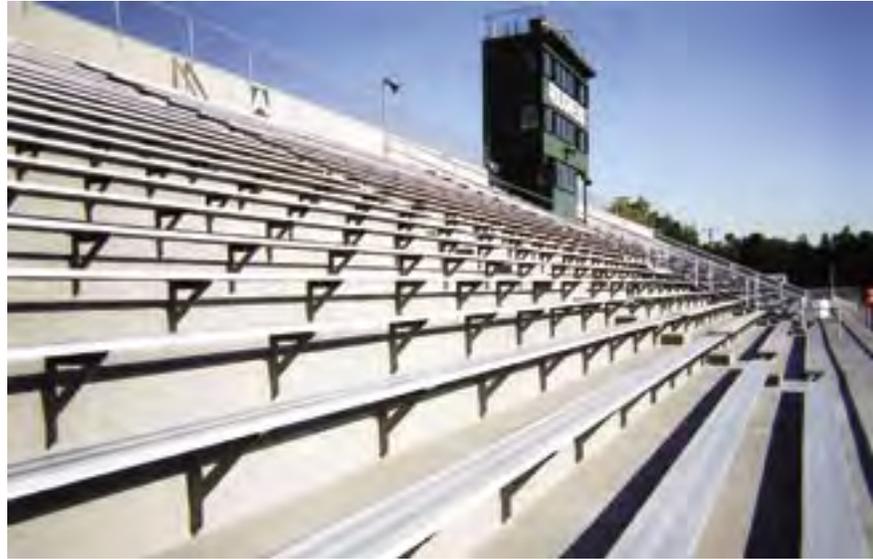
*Color-matching the new top coat applied to vertical surfaces and the elastomeric coating used for vertical walls resulted in a crisp, coordinated look and prime protection for Muskogee’s landmark stadium.*

This engagement, Western crews power washed the old coating, repaired damaged areas, and recaulked expansion joints. They then applied over 500 gallons of new top coat with sand back-rolled into it. Next followed an application of a color-matched elastomeric coating to all vertical walls.

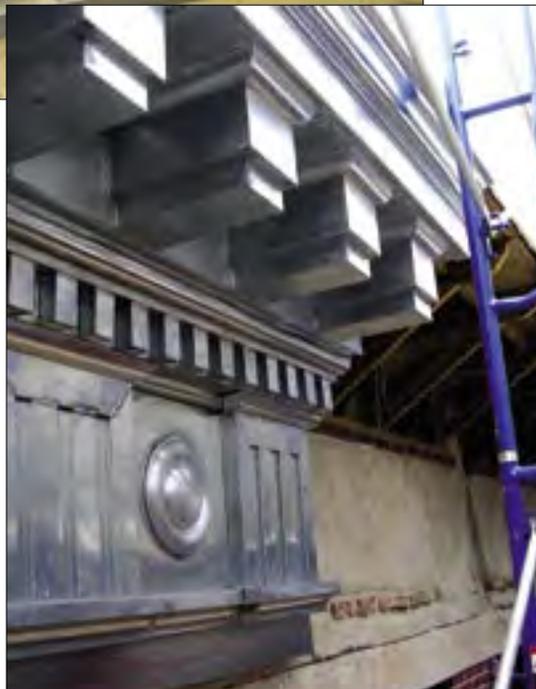
*Seventy years of wind and weather had compromised the intricate beauty of 40 Tiemann’s distinctive metal cornices. Craftsmen from Michigan Ornamental fabricated 144 lineal feet of design-enhanced replacements to restore the building’s original elegance.*

The new cornice was constructed of galvanized metal in eight-foot lengths, the industry standard for production and installation efficiency. Each piece was 48 inches high and constructed from five horizontal sections with different configurations. Some 80 panels contained spinnings.

To expedite restoration, Michigan produced the sections in three groups of six, allowing placement to begin while fabrication concluded. The crew also crafted and attached 84 brackets to a section of the upper cornice, along with 350 dentils, to speed installation.

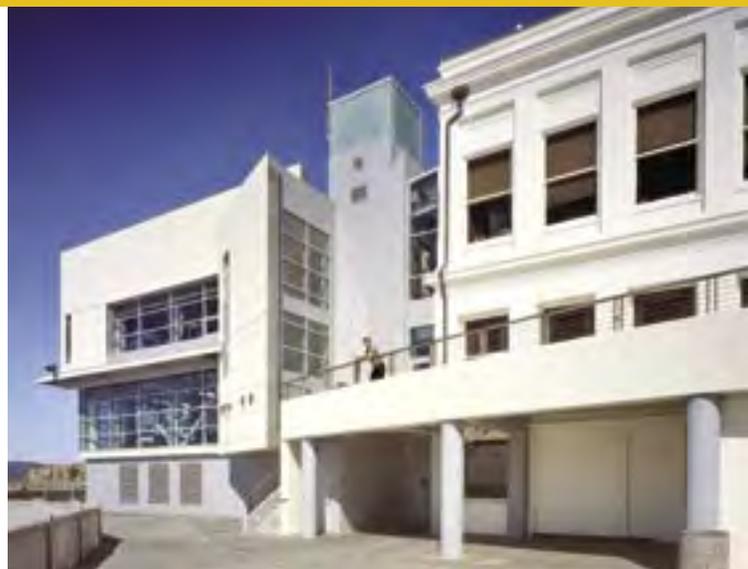
In late 2002, Western Waterproofing's San Francisco branch was asked to partner with Nibbi Brothers Construction and C. David Robinson Architects to restore portions of the Cliff House and expand the entertainment areas. Extensive research revealed that the building was constructed of concrete with details of putty parging.

Plans called for rebuilding structural concrete base shapes and then applying putty to create column capitals and bases, cornices and other architectural elements. All of the products used would be stringently

A structural engineer was consulted when subsequent problems surfaced. Western performed the structural repairs indicated and added galvanic anodes to further reduce the effects of corrosion of the steel structural elements. Western was also asked to handle the temporary relocation and replacement of an historic Camera Obscura located on the edge of the cliff.
