WEATHER VANE

Published by
WESTERN CONSTRUCTION GROUP

Austin's Historic Littlefield Restoration Merits Western Expertise

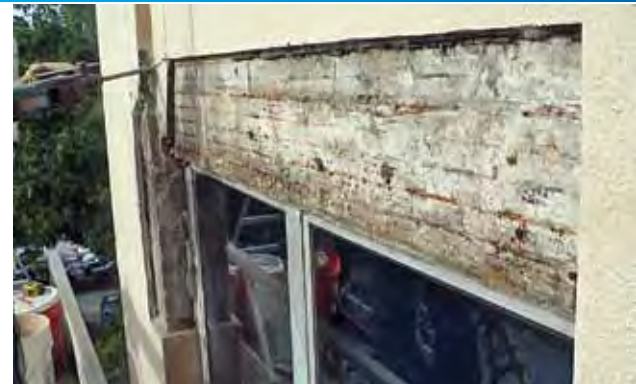
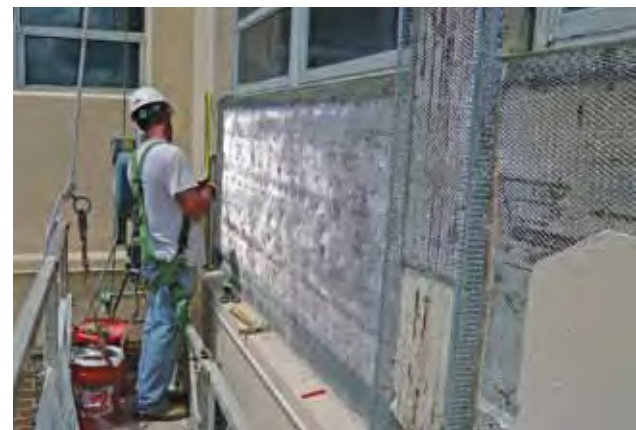
The scope of the 32 West Gore project increased significantly when Western discovered lath deterioration four inches deep—twice that originally anticipated. Swing-stage work requirements and ongoing tenant/guest access made safety a primary consideration. Both the finished project and Western process earned Orlando Health praise.

“The building had experienced serious water infiltration,” confirms Western branch manager Chester Scott. “Our scope of work included removing the failed stucco, replacing sealants and applying Tremco waterproofing to the full exterior of the building. Destructive testing was not conducted prior to our beginning work, however, and our crews realized early in the process that deterioration was more severe than had been anticipated. The budgeted quantity—1,500 square feet—was on target, but there were areas with damage and corroded lath four inches deep, and our specified patch repair was just half that.”

regarding the enlarged scope. Scott continues, “We were able to replace the entire lath in the repair areas and 100 percent of the stucco. Sealant replacement and Tremco waterproofing then proceeded according to the original plan.”

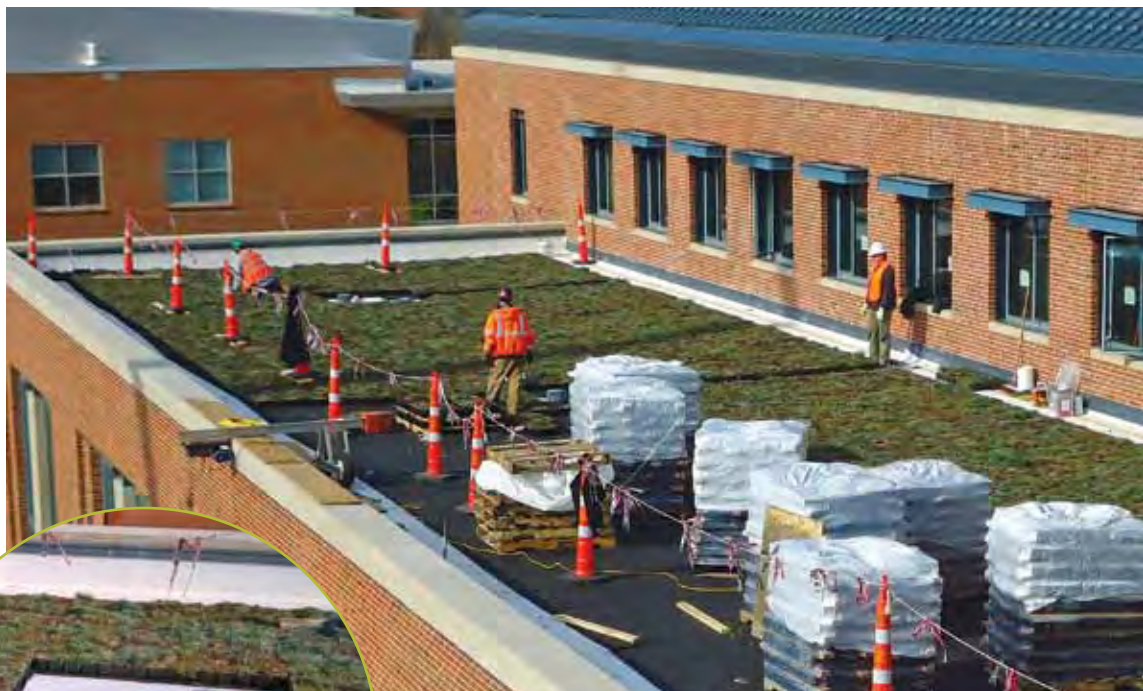
A total of 1,600 vegetation trays, each two-foot square, were secured to the two green sectors to create the lushly landscaped roof. Fully adhered TPO membrane was applied to the entire roof, with tapered insulation affixed to the non-green sector.

The overall roof design called for two green sectors and a third traditional surface. Each of the green areas received a base layer of fully adhered TPO membrane, to which some 1,600 vegetation trays—each 24-by-24 inches—were secured. The remaining roof system included fully-adhered TPO membrane adhered to tapered insulation.

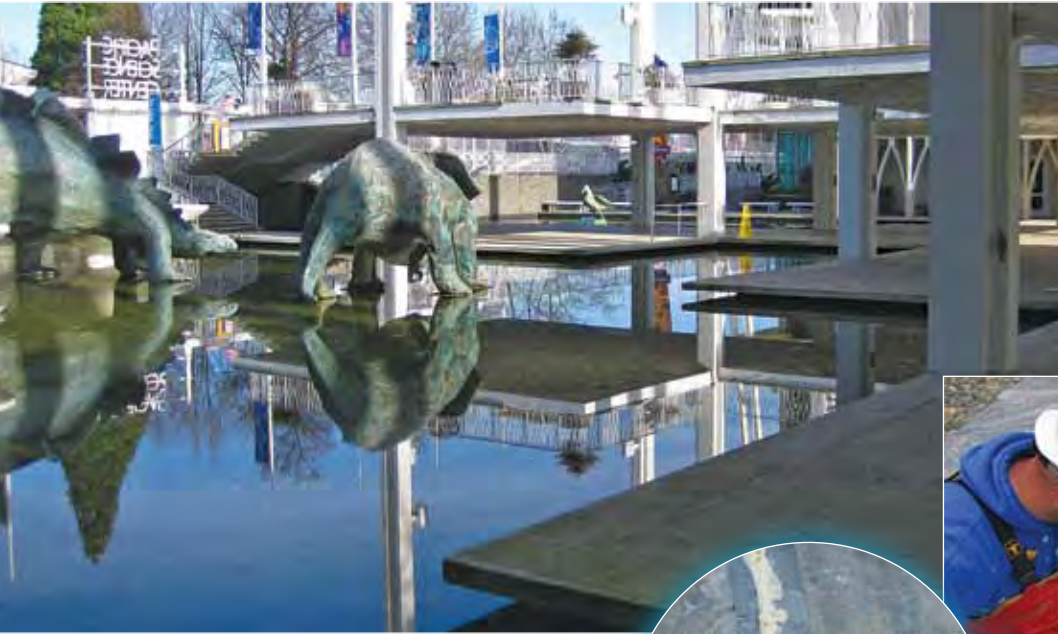
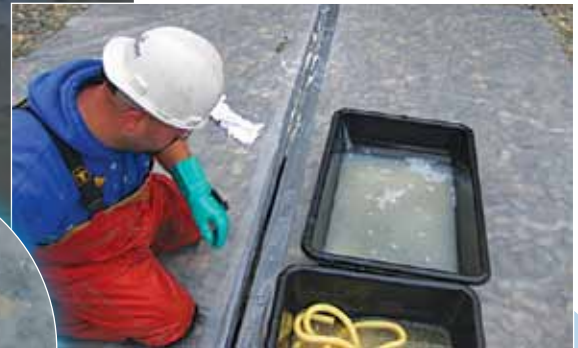
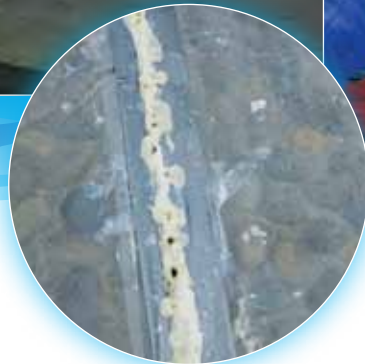
With Western’s innovative solution, water loss at the iconic ponds dropped from 55,000 gallons per day to virtually zero.

When Western’s Seattle branch was contracted to find a solution, a new strategy was devised. Branch manager David Kimble explains, “We developed a scope that included removing the deteriorating wood expansion joints, then installing a chemical grout in the

open joints as a primary seal. We then installed a secondary, sanded caulk joint at the top for aesthetic purposes.

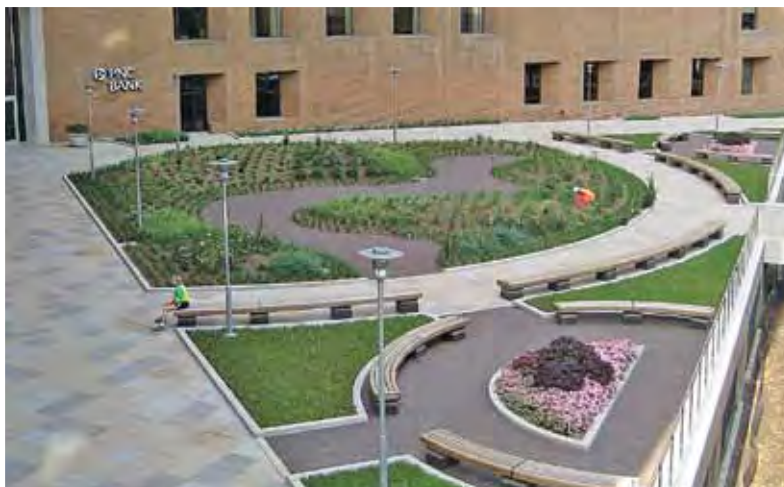
Western crews helped transform the PNC Center’s deteriorating all-concrete plaza into an inviting oasis of hardscape and landscape. REIT Management reports receiving “nothing but positive feedback” from tenants and Indy city officials.

“Our scope of work included demolition of the existing concrete planters and topping slab, down to the structural deck,” Berndt continues.

“After repairing the concrete, we installed a hot-applied waterproofing membrane system and installed new topside finishes, including an open joint paver system. High-end handrails, a new pedestrian bridge linking the plaza deck to the Washington Street sidewalk, and the green landscaping rounded out the project.”

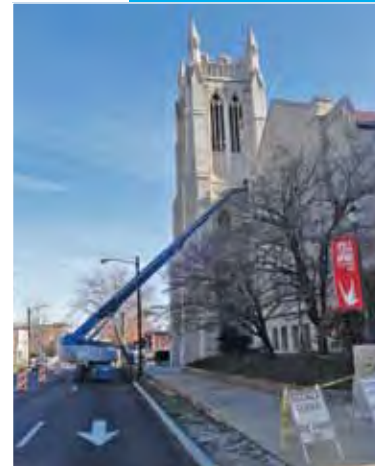
At 102 feet, the bell tower of the First Christian Church presented access challenges for Western crews tasked with repairing the tower's stone mullions.

The project scope was extensive, Rehtin confirms. "We were contracted to tuckpoint 100 percent of the mortar joints, and to remove and replace all sealants at the capstones, windows and door frames. There was spalled limestone in need of patching, and we had to repair the stone mullions on the bell tower openings and stained glass windows, which rise 22 and 36 feet high."
